# Machining advice for fitting of stepped Cylinder Head Studs

## Part R562-S Issue 1 Issued for use - OCT 2020

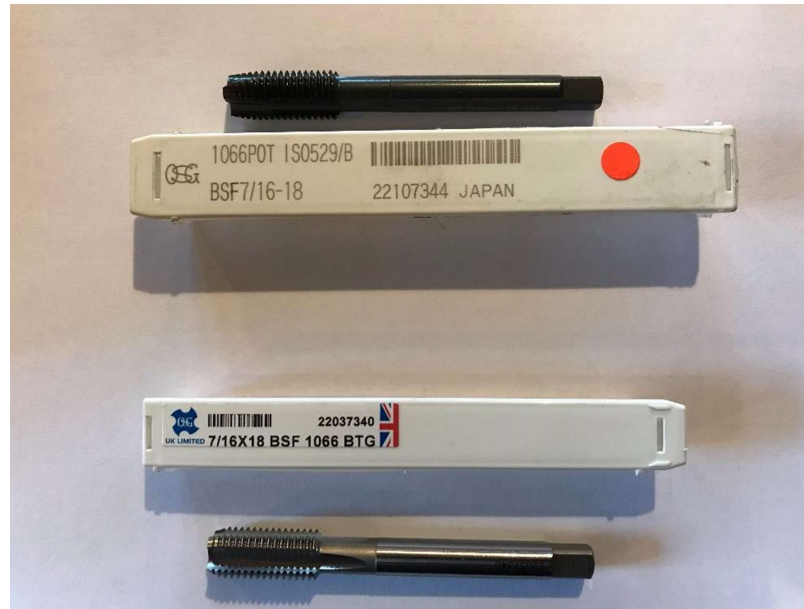
The upper tap (OSG 1066 POT) is for starting the thread and should be supported/guided inline with the hole by a mechanical means in order to maintain squareness to the cylinder block.

The Lower Tap (OSG 22037340) is a plug Tap for Finishing the Thread to the Bottom of the Hole.

Details of the taps are shown below.

If you are tapping a Block that has through holes into the water jacket, then you may only need the Upper Tap (OSG 1066 POT).

If you are repairing a Block that has blind holes that do not enter the water jacket then you will require both Taps.
